3.0 AFFECTED ENVIRONMENT

3.1 Introduction

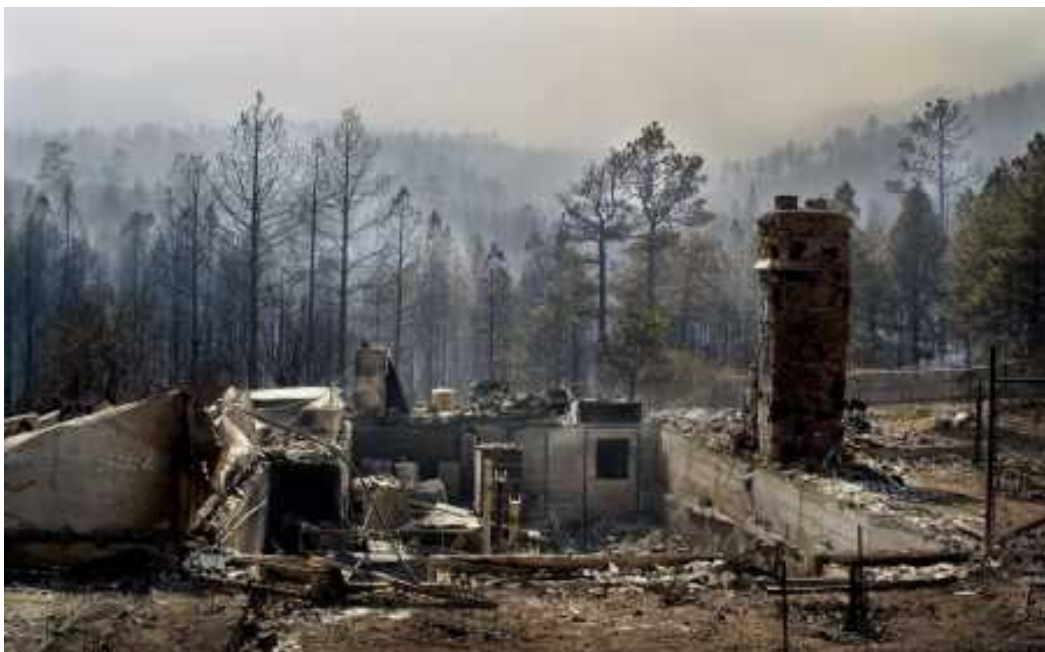
PHOTO 3.1—*Burned Residential Unit in Los Alamos Townsite*

One of the primary land use zones within Los Alamos townsite is residential. About 230 housing units in that zone were totally destroyed (Photo 3.1). Within LANL, the structures that were totally destroyed, including trailers, transportables, and storage units, numbered about 40 (personal communication, H. Nunes).

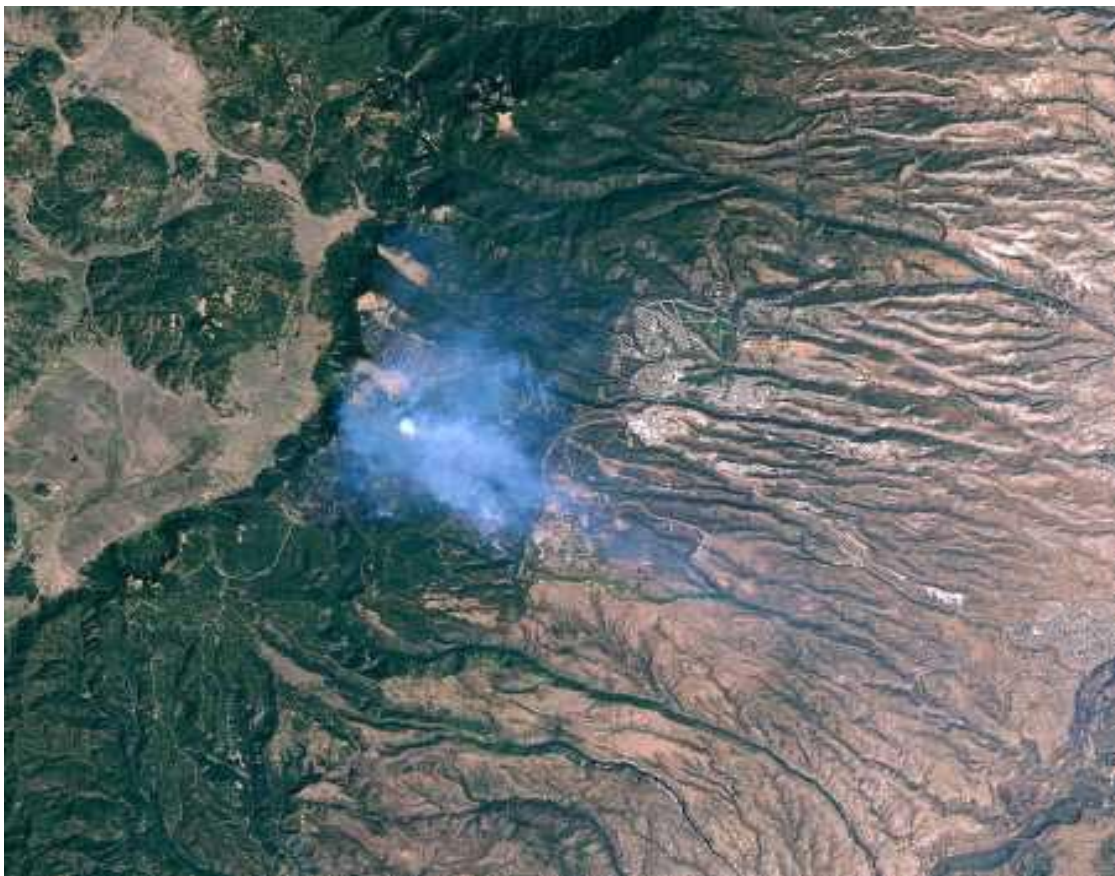
PHOTO 3.3—*Smoke from the Cerro Grande Fire Spreads Eastward toward LANL*

The Cerro Grande Fire's primary effect on air quality in the ROI was a temporary increase in smoke (Photo 3.3) and increased concentrations of radioactive constituents, particulate matter, and other chemicals (discussed in following paragraphs). The only longer-term effect is a probable increase in suspended particulate matter due to removal of vegetation; over the longer term (one to three years), the loss of vegetative cover would increase the likelihood that particulate matter would become airborne. Until vegetation is re-established, the amount of suspended particulates could increase, but air quality would still be within the parameters analyzed in the 1999 LANL SWEIS.

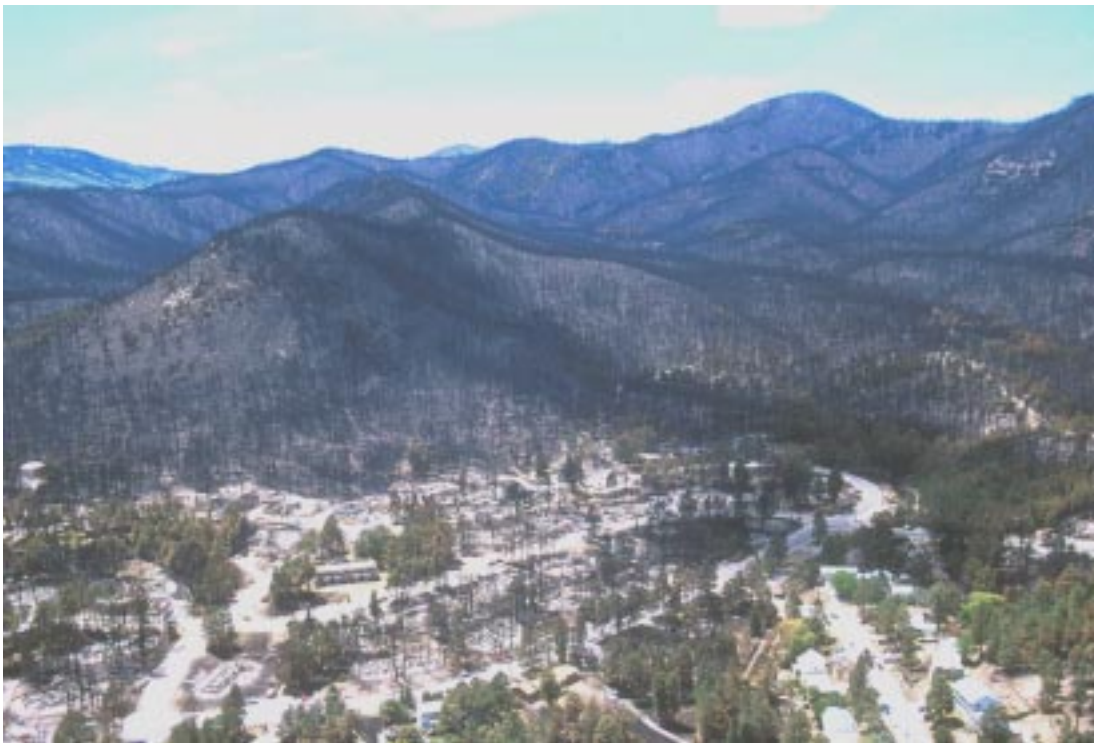
PHOTO 3.4—Severely Burned Mountain Slopes above Los Alamos Townsite

Views from various locations in Los Alamos County and its immediate surroundings have been altered by the Cerro Grande Fire. Although the visual environment is still diverse, interesting, and panoramic, portions of the visual landscape are dramatically stark (Photo 3.4). Rocky outcrops forming the mountains are now visible through the burned forest areas. The eastern slopes of the Jemez Mountains, instead of presenting a relatively uniform view of dense green forest, are now a mosaic of burned and unburned areas. Grasses and shrubs initially will replace forest stands and will contribute to the visual contrast between the burned and unburned areas for many years.

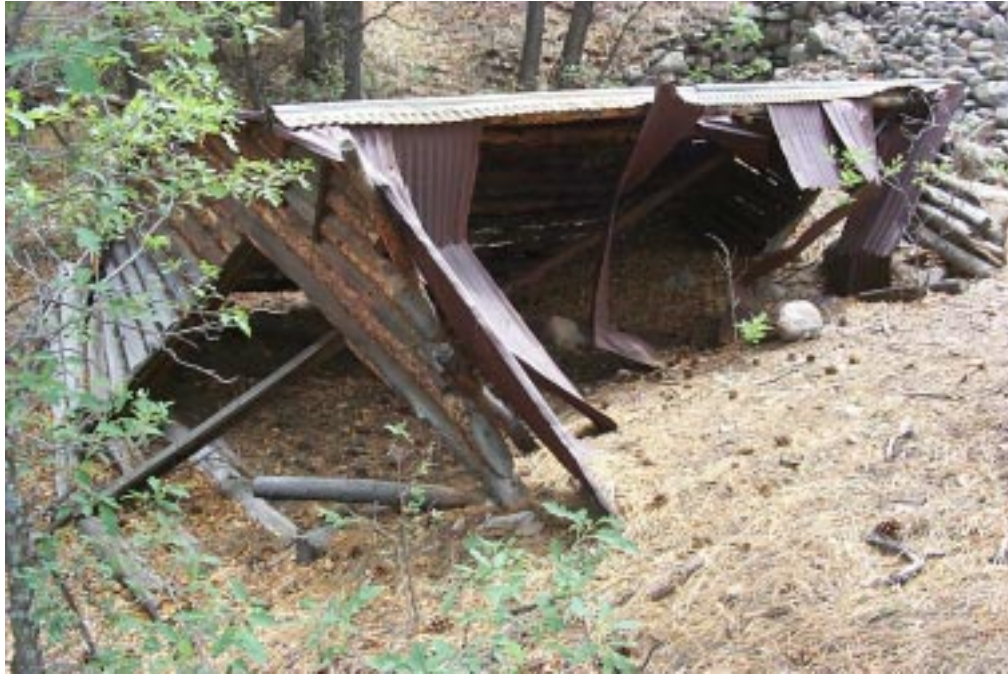
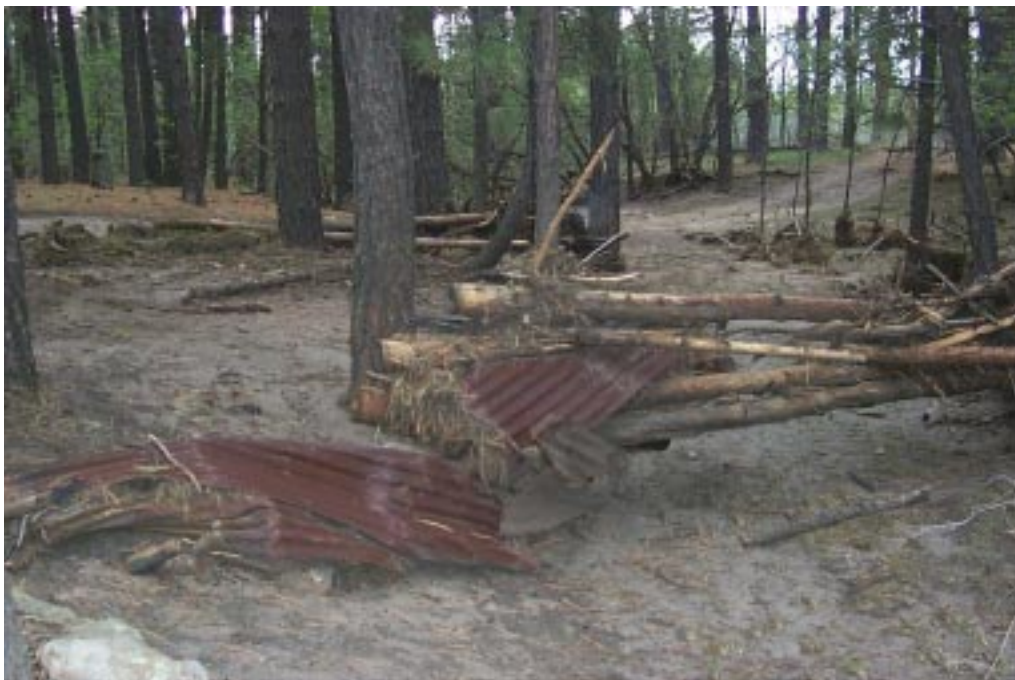
PHOTO 3.5—Anchor Ranch Icehouse before June 28, 2000, Flooding

There has been a significant loss of Homestead Era historic sites in the Jemez Mountains/Pajarito Plateau area as a result of the Cerro Grande Fire and previous wildfires such as the Dome Fire in 1996. The structural remains associated with the homesteads are rapidly dwindling throughout the region. Before the fire, LANL’s historic homesteads were among the best remaining evidence of this period. Virtually all wooden buildings associated with the Homestead Era were destroyed by the fire and the sites were largely reduced to rubble. On June 28, 2000, an intense rain also produced

flooding that destroyed an already deteriorating Homestead Era icehouse structure (Photos 3.5 and 3.6).

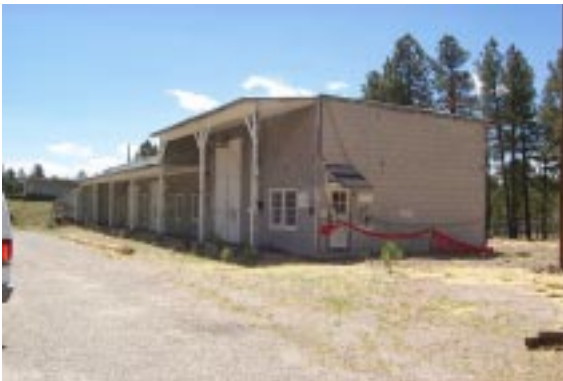
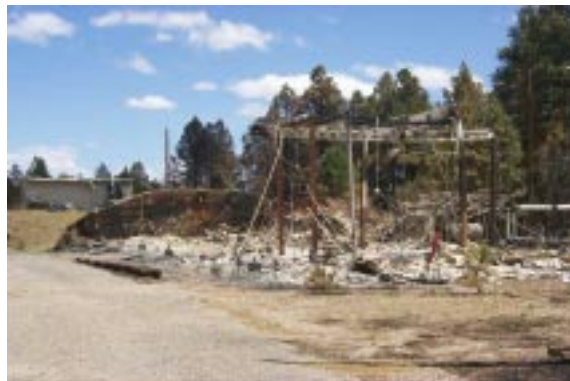
PHOTO 3.7—V-Site in 1999

The V-Site was abandoned in the early 1950s, and its buildings were slated for demolition. However, in May 1999, the White House Millennium Council awarded the V-Site a grant under the Save America's Treasures program to restore, preserve, and use these buildings as a museum and interpretive center for the Manhattan Project. The Cerro Grande Fire largely destroyed portions of this site and its remaining artifacts. Photos 3.7 and 3.8 illustrate the "before" and "after" effects of the fire.

All but one building of the Manhattan Era V-Site was destroyed by the fire. Program planning was underway to restore the V-Site buildings, build a road into the site to allow public access, and create a world-class interpretive center and museum on the history of the Manhattan Project before the Cerro Grande Fire. The V-Site renovation was being collaboratively undertaken by DOE, LANL, the Bradbury Science Museum, and Recursos de Santa Fe. Historic artifacts associated with a former casting building at TA-16-27 were stored in TA-16-518, a long wooden shed at V-Site. Most of the artifacts were destroyed and the artifacts that remain have fire damage. The program planning is now being revised because of the cultural resources changes at LANL attributed to the fire.
